Project NY 450 004.4
Technical Note N-217
11 April 1955

CATHODIC PROTECTION STUDIES, November 1953 to
November 1954

U. S. Naval Civil Engineering Research and Evaluation Laboratory
Port Hueneme, California

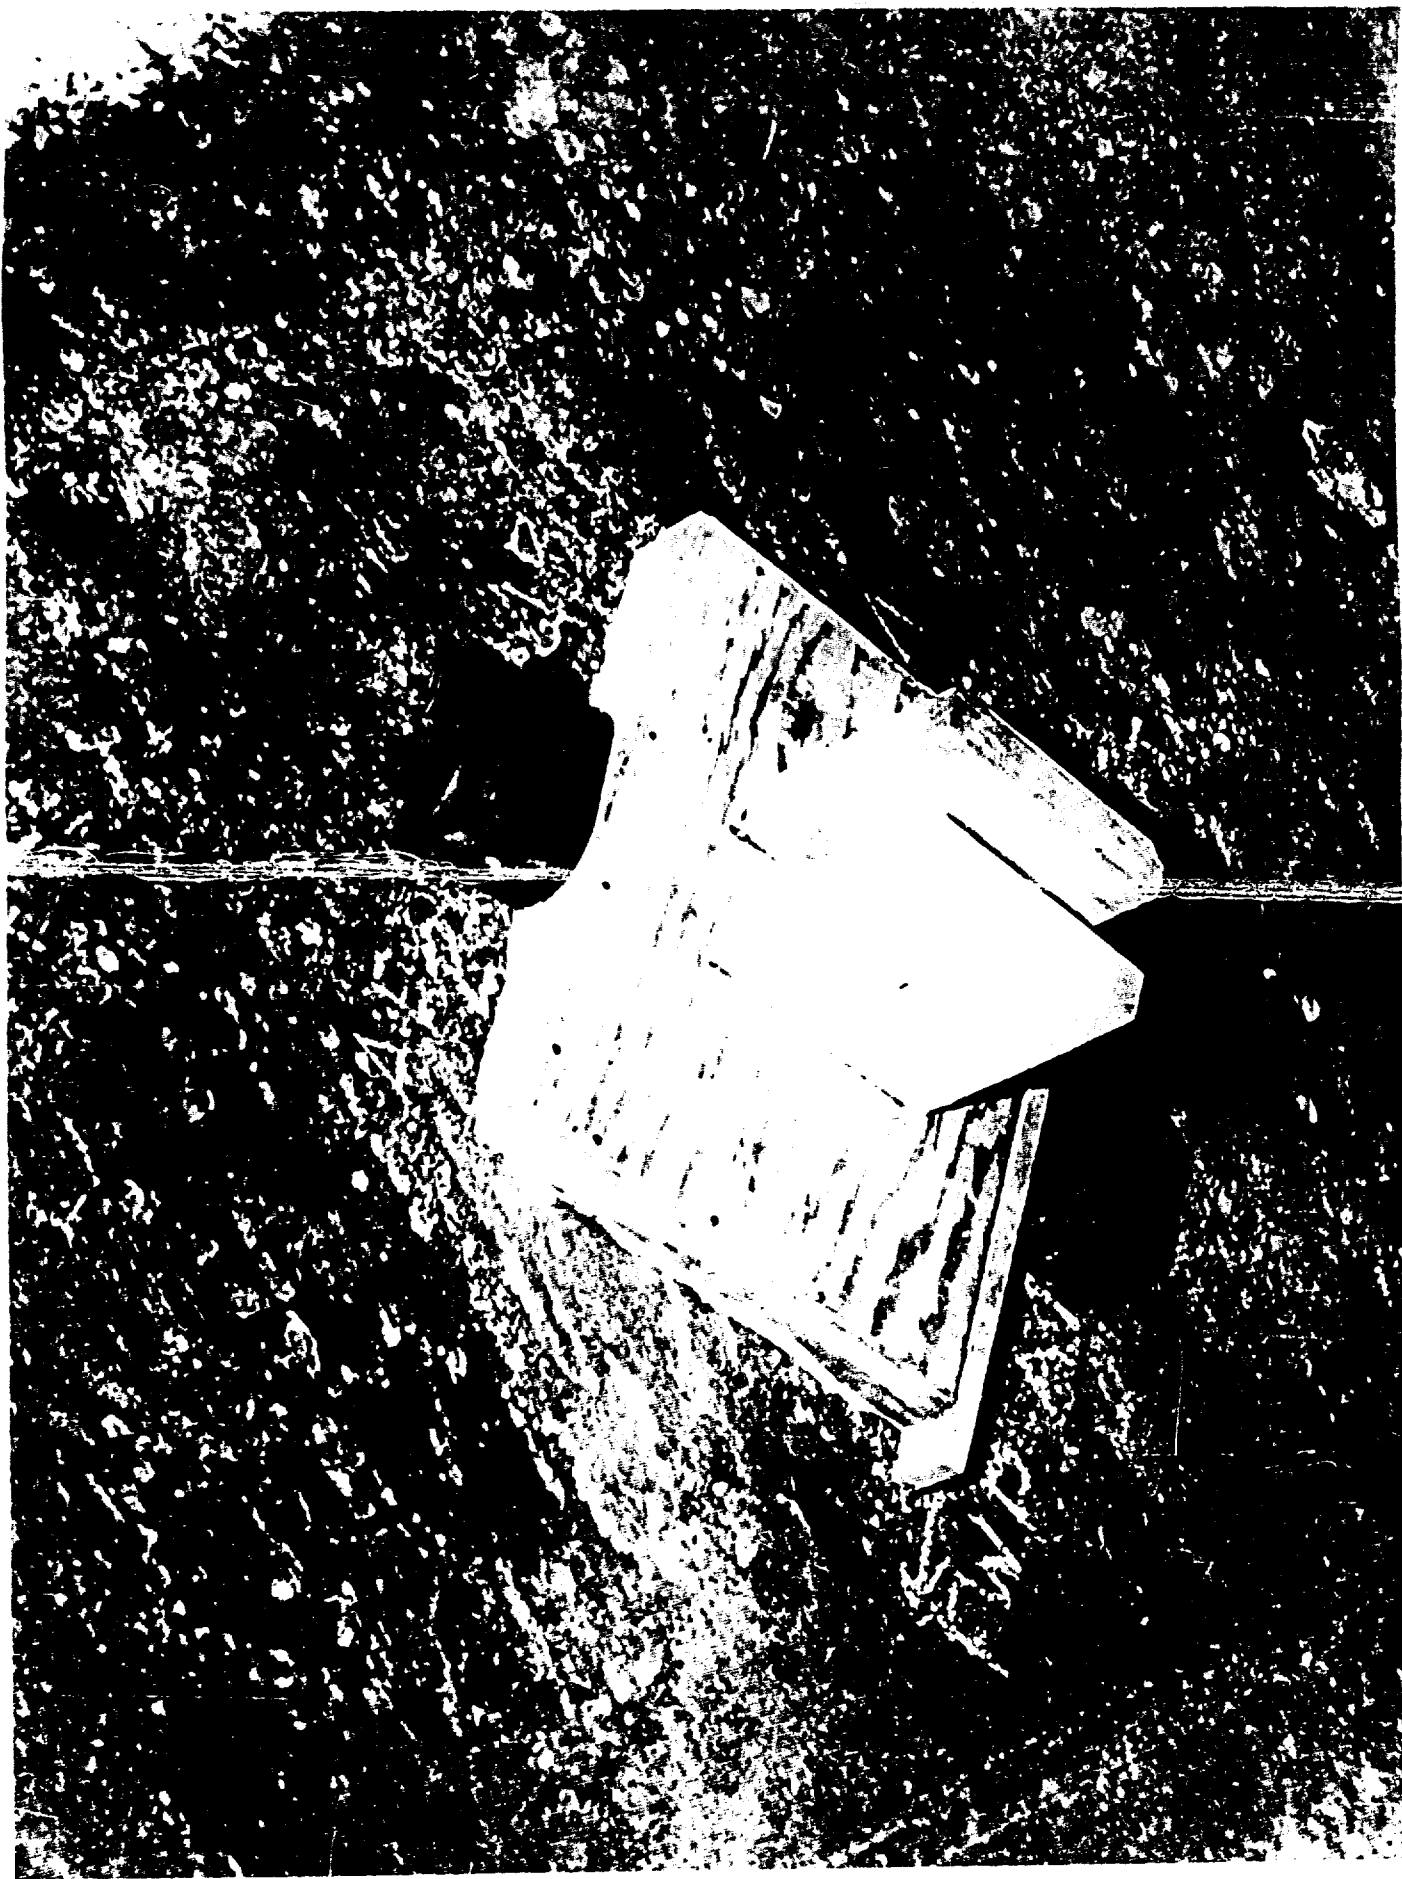
Figure 9. Hydrostone mold in position on a dry-dock hull.

A means of permanently recording the physical condition of the hull in selected areas before and after periods of protection to determine the effects of CP in existing pits and the possible formation of new pits has been attempted by making an impression mold. The mold is made with hydrostone (a fine grade of gypsum cement) with dimensions of 12"x9"x1". The hull area is carefully sandblasted, marked with metal punches for identification, and coated with a thin film of light oil to prevent the hydrostone from sticking. The hydrostone is thoroughly mixed with sufficient water to make a thick slurry and then poured into a wooden mold. The slurry is repeatedly troweled to work as much of the air out as possible and to present a smooth surface. The mold is then placed against the hull in the desired location and allowed to stand for approximately 45 minutes before removing. Figure 9 shows a mold in position with two 100 lb pull, permanent magnets firmly anchoring it to the hull. Six or eight such impressions were taken of each hull. One area was selected for both bow and stern and two or three on each side amidships, depending upon the available time. The amidship positions were usually taken at the waterline, approximately 4 feet below the waterline and on the bottom. The areas were carefully located as to the distance from welded seams, draft numbers, or other identifying marks on the hull. This information will be used

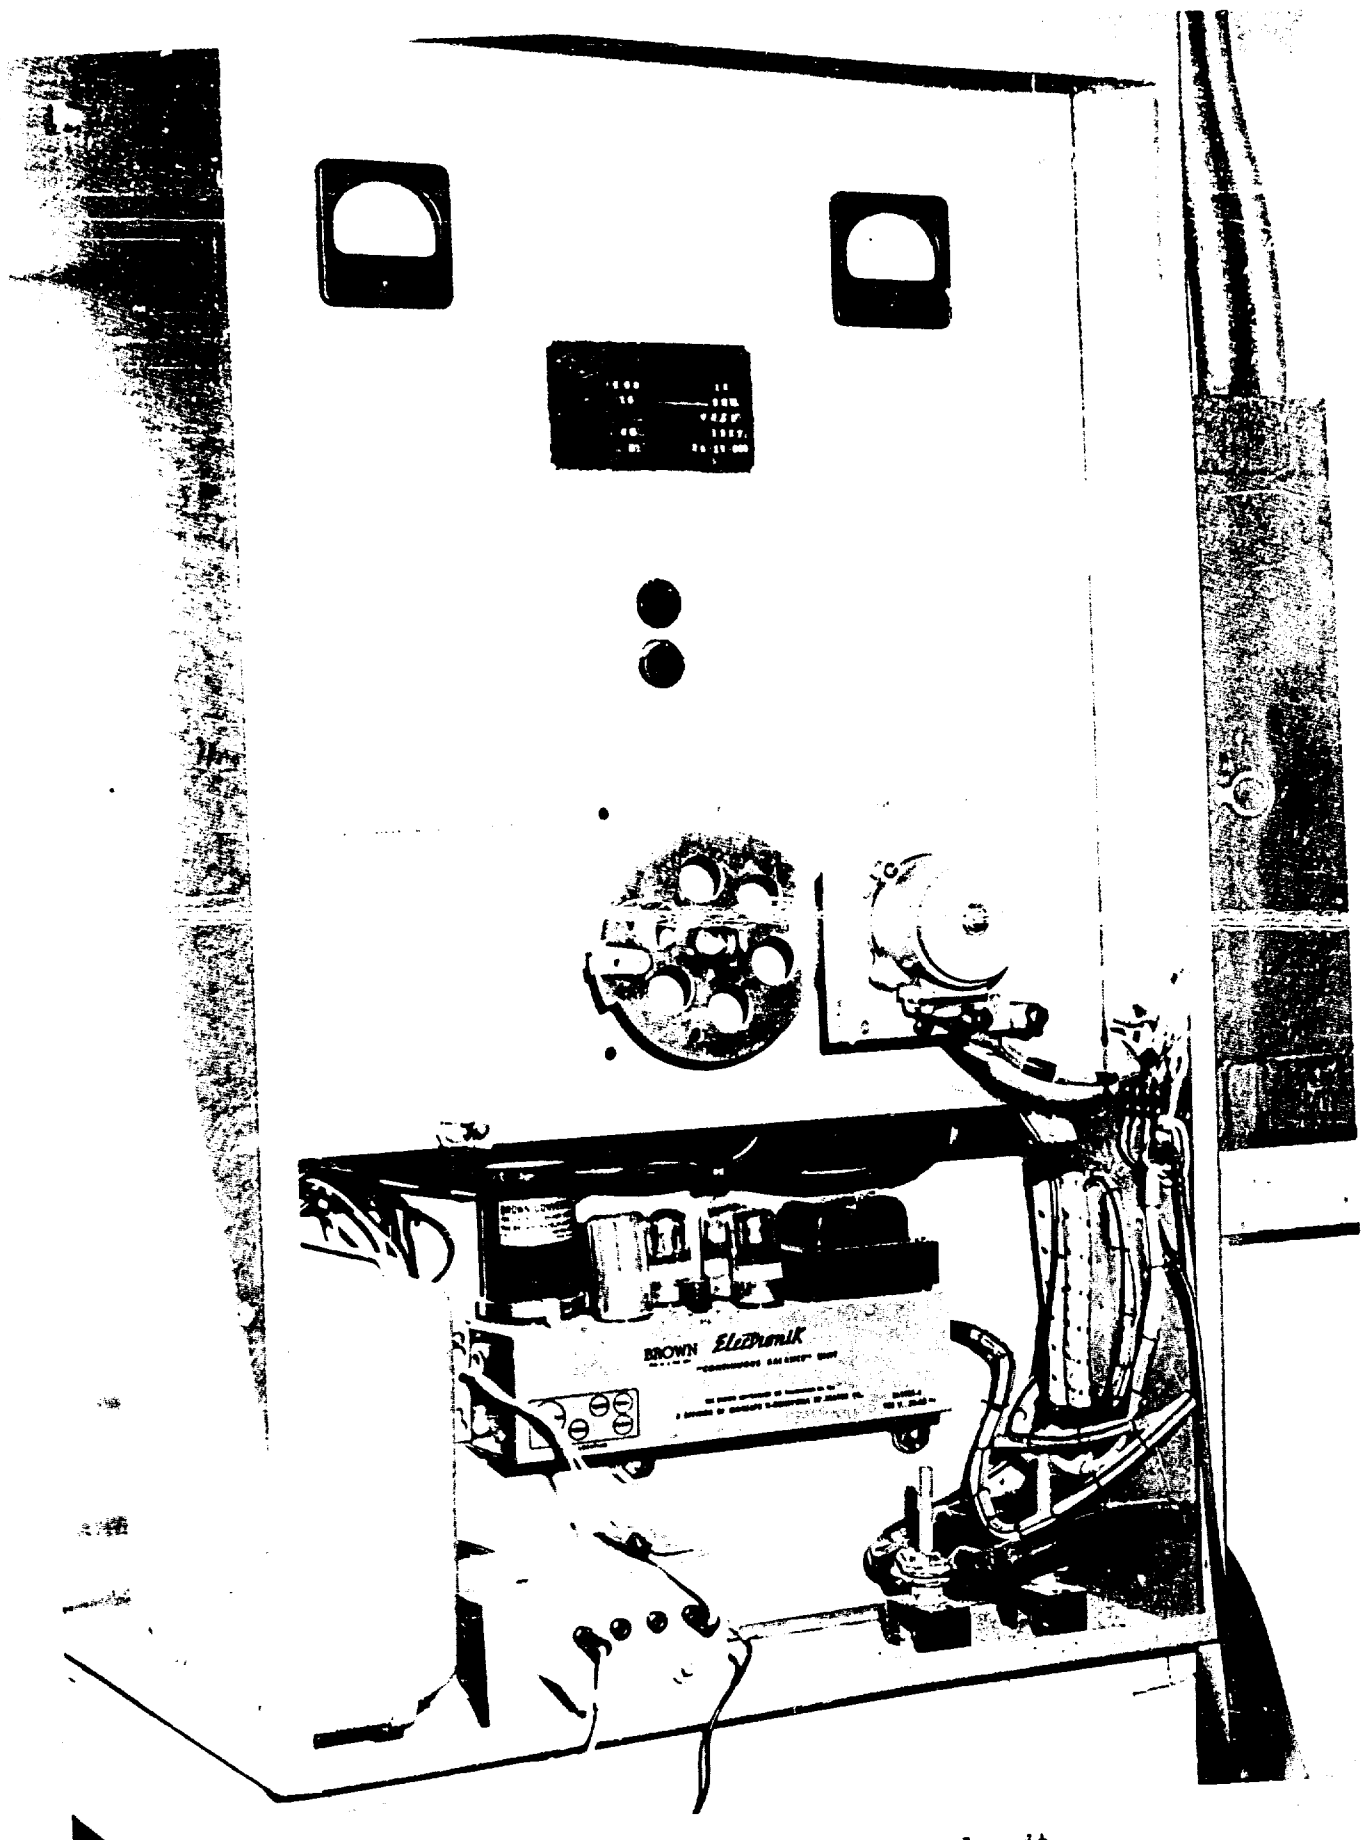
Figure 17. Automatic current control unit mounted on rectifier panel.

The amplifier and servo system as shown in Figure 17 have proven to be a compact, efficient unit and have required no maintenance in six months of operation. Initial installation of an electronic system rather than a complete magnetic amplifier type system, which would have inherently longer life, was made primarily for economic reasons. There are no complete magnetic amplifier-type systems commercially available, and the development of a unit would have to be made at considerable expense. The electronic equipment was installed at a cost of approximately \$200.00, with negligible modification of the power supply equipment. The limitations of the available signal power (order of 10^{-9} watts) is within the range of the input characteristics of electronic amplifiers. Magnetic amplifiers capable of operating at such a low signal power are still in the development stage.
